LOCKLIN POND DAM

NDI ID NO. PA-00139
DER ID NO. 64-31

PHASE I INSPECTION REPORT
NATIONAL DAM INSPECTION PROGRAM

JULY 1980

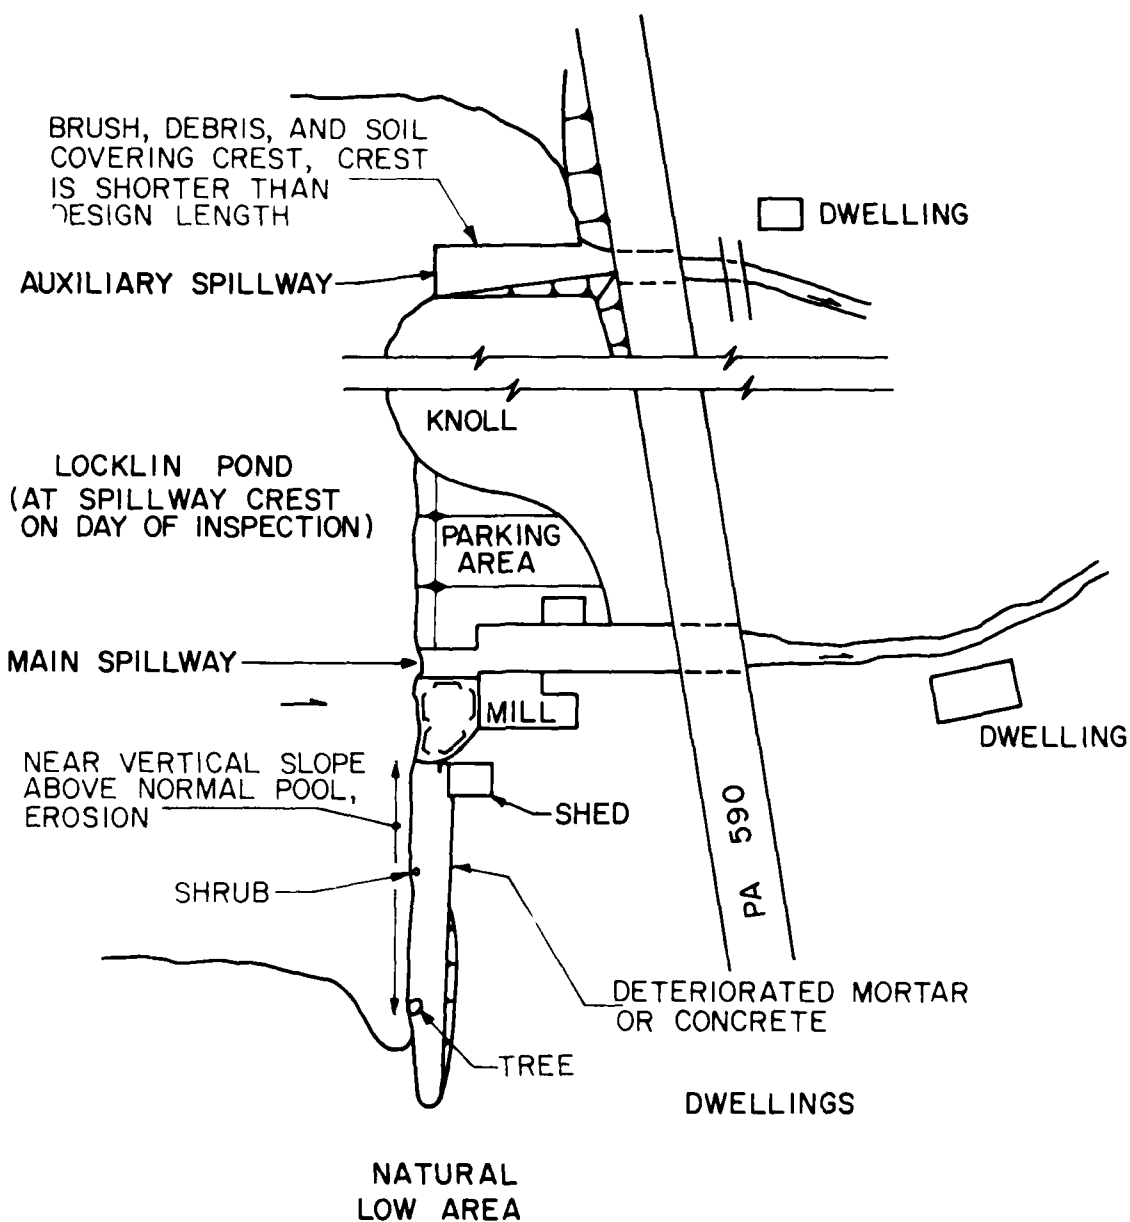
EXHIBIT B-1

a. General. The overall appearance of the dam is good. Some deficiencies were observed as noted below. A sketch of the dam with the locations of deficiencies is presented on Exhibit B-1 in Appendix B. Survey information acquired for this Report is summarized in Appendix B. Datum for the survey was taken at the top of the downstream wingwall of the highway bridge downstream from the main spillway, Elevation 1252.22. On the day of the inspection, the pool was at the spillway crest level.

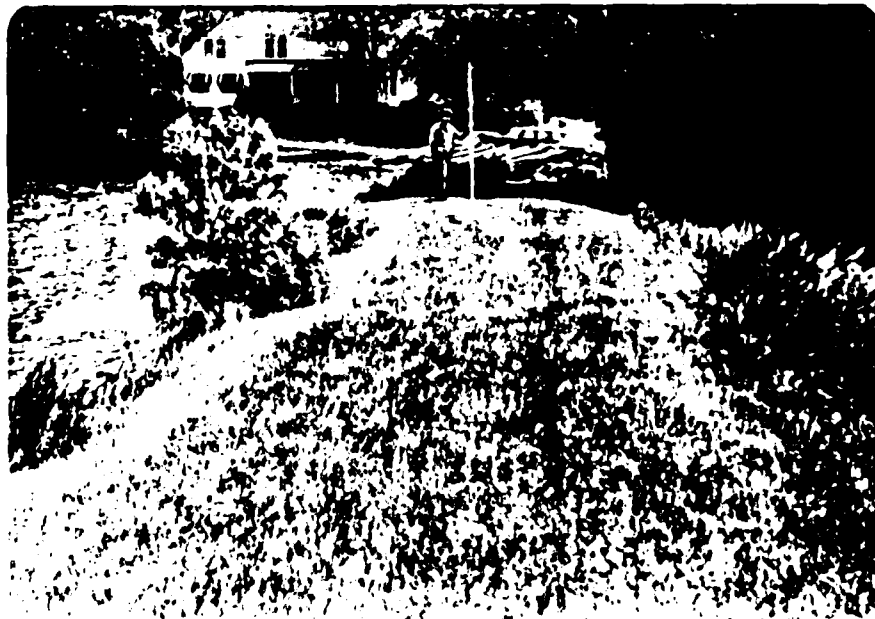
b. Embankment. The embankment is in generally good condition. To the left of the main spillway, the embankment is covered with a shale fill; no deficiencies were observed in this area (Photograph A). To the right of the main spillway, the embankment is covered with grass, except where the downstream slope is a vertical wall. The top is well maintained (Photograph B). The upstream slope is near-vertical along most of its length. There is evidence of erosion along most of the slope. The most severe erosion has occurred near the right end; here the erosion encroaches 3 feet into the top over a 3-foot long reach (Photograph D). One shrub is growing on the upstream slope. Near the right end, a 20-inch diameter tree is growing on the embankment.

(2) Embankment. The growth of the tree on the upstream slope is a minor hazard at present. Root systems of large trees can loosen embankment material, displace slope protection, and create paths along which seepage and piping (internal erosion) might occur. Because of the wide topwidth and low height of the embankment near the tree, the hazard is only considered to be minor. The other small shrub on the upstream slope is no hazard at present, although further growth is undesirable. Although the erosion on the upstream slope is significant, it is not an immediate hazard because of the wide topwidth. Further erosion would soon become a hazard. The deterioration of the mortar (or concrete) in the wall that is at the downstream side of the embankment is a maintenance deficiency.

B. Embankment Right of Main Spillway

(5) Repair the eroded areas on the upstream slope and provide suitable erosion protection.
